CONTINUING ELIGIBILITY INSPECTION (CEI) REPORT

FOR FLOOD CONTROL WORKS
Honolulu Engineer District
CEPOH-EC-T

1. Project Name: Kuliouou Stream Flood Control Project
2. Date of Inspection: November 6, 2007
3. Inspection Personnel:

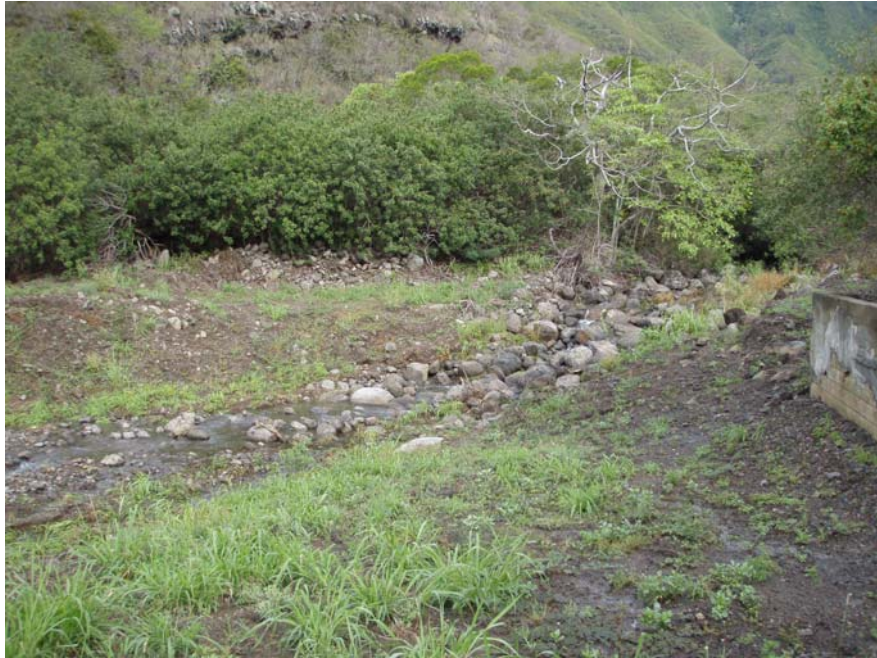
a. Debris Basin - Remove boulders from upper reach of debris basin.

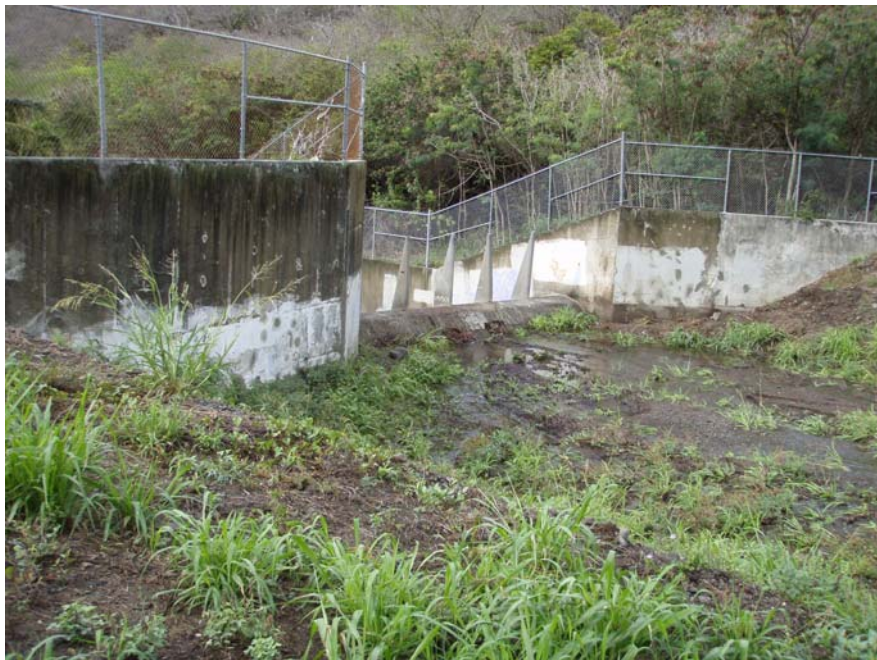
b. Sta. 72+00, Debris Basin, missing drainage grating replaced, continue to remove debris.

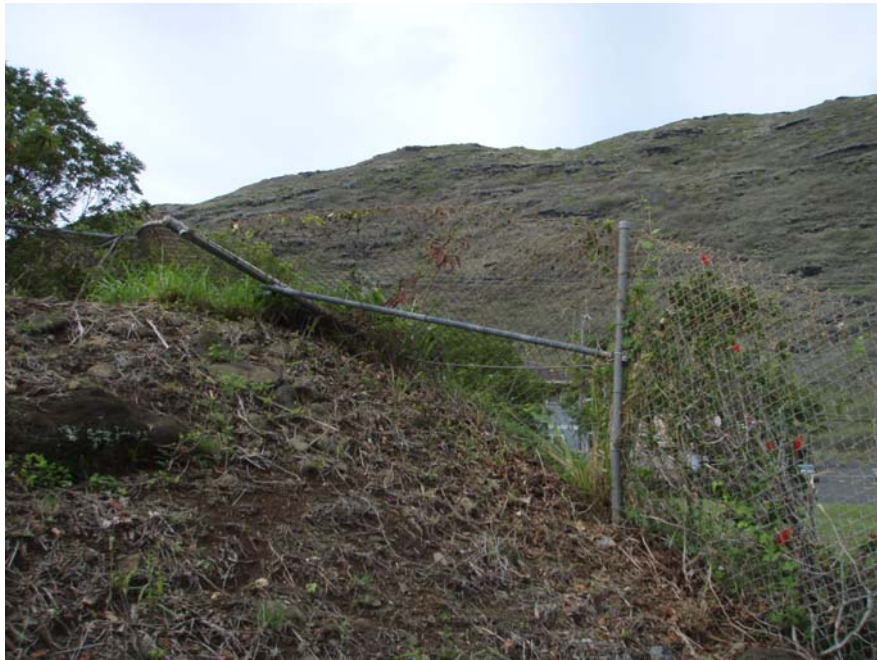
c. Sta. 46+50, LB, repair maintenance access road fence.

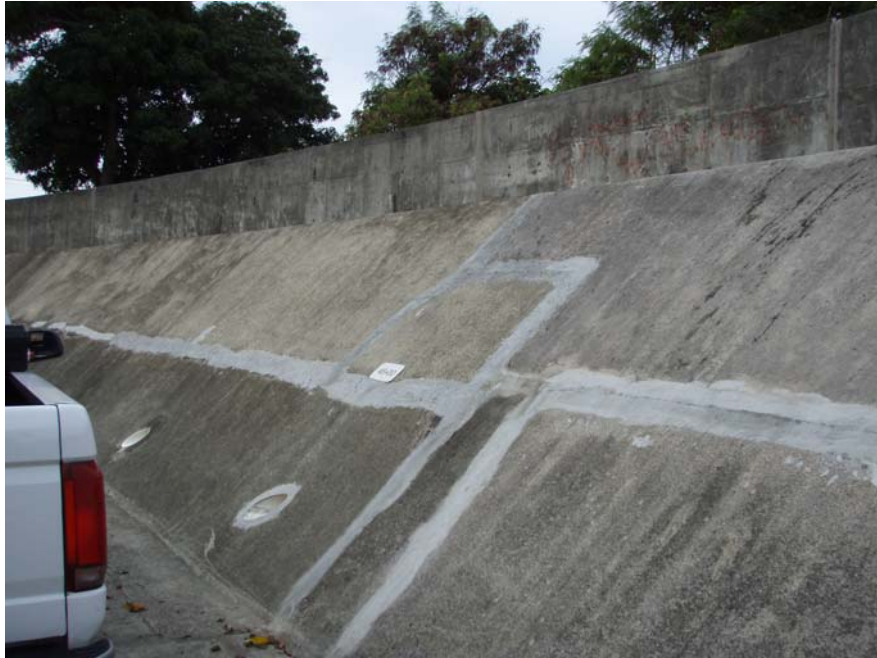
e. Sta. 46+30, RB, cracks repaired.

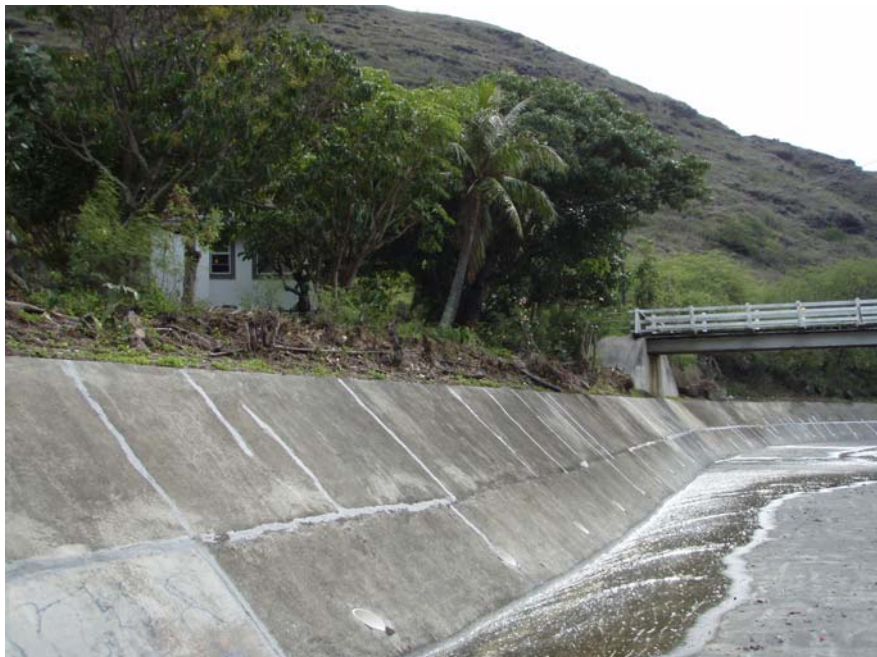
f. Sta. 44+50, LB, reestablish maintenance easement, remove trees as needed.

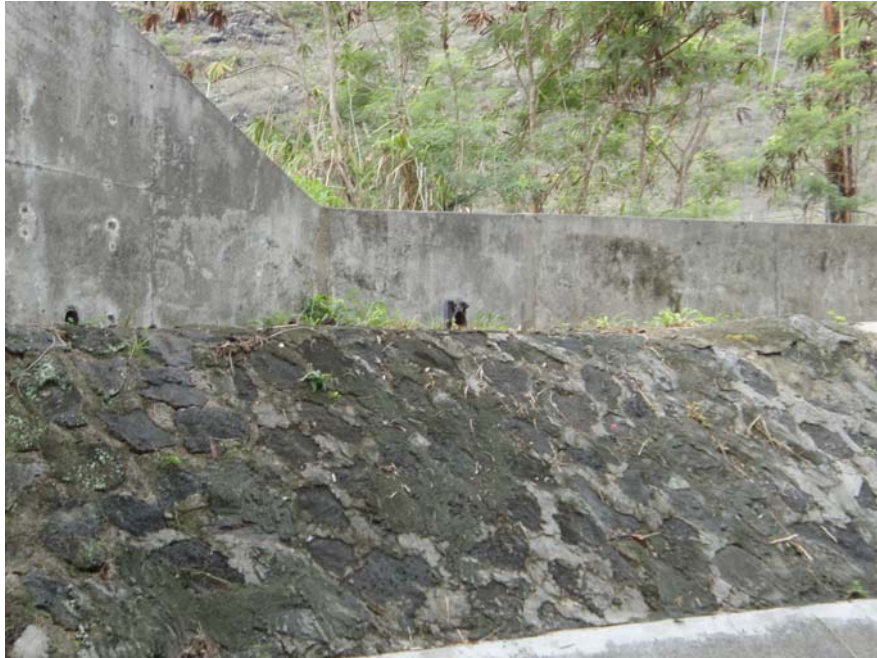
g. Sta.44+50, RB, replace missing 6" flapgate and remove debris.

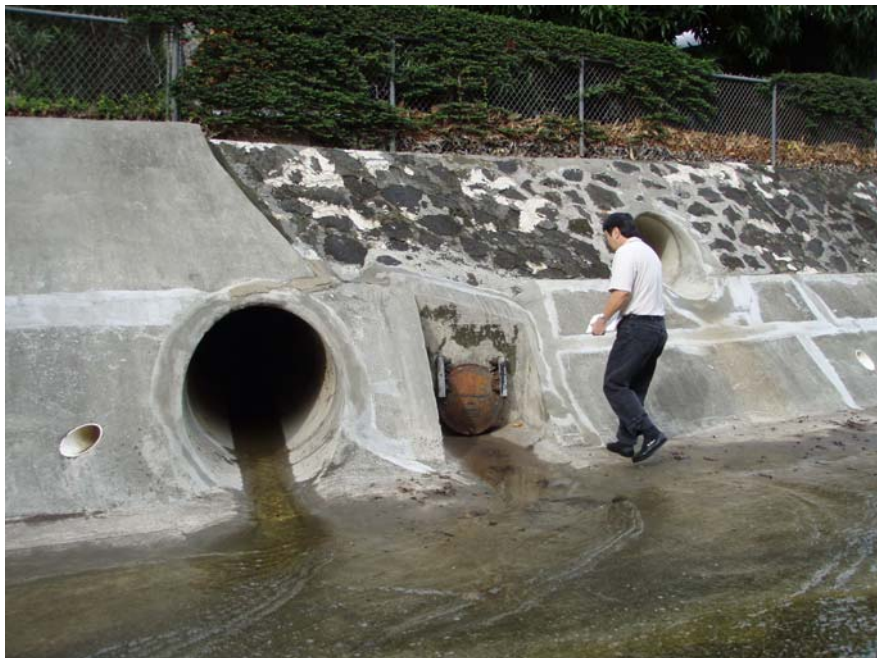
h. Sta. 37+50, RB, grease flapgate hinges, (typical through-out project).

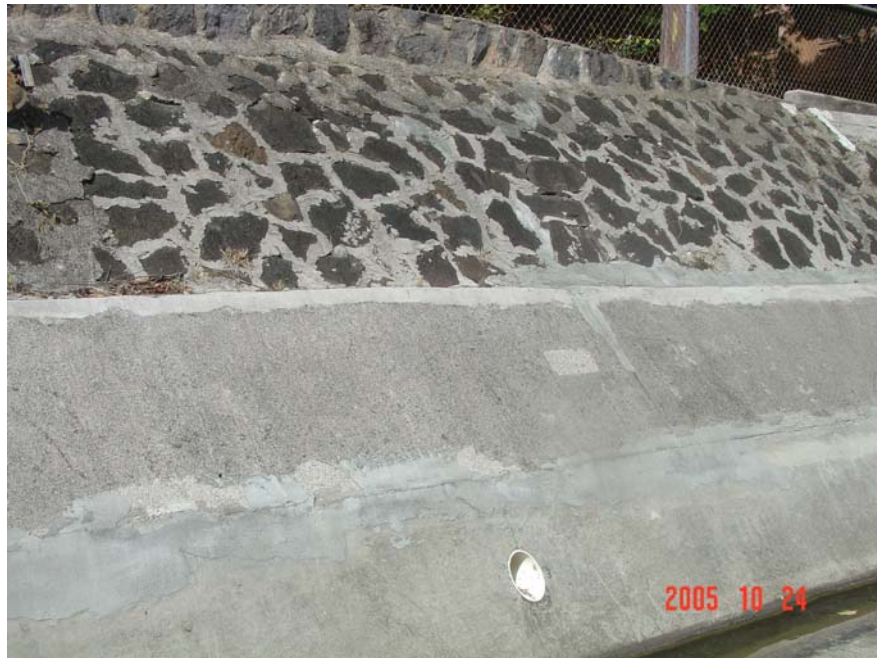
j. Sta. 30+00, RB, replace missing station numbers (typical through-out project).

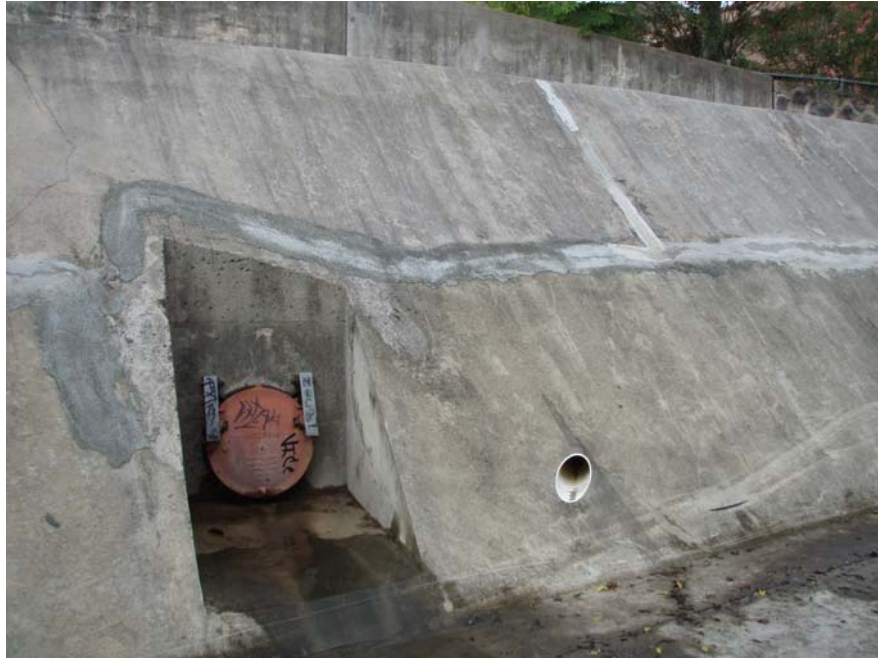
k. Sta. 29+15, RB, Grease flapgate.

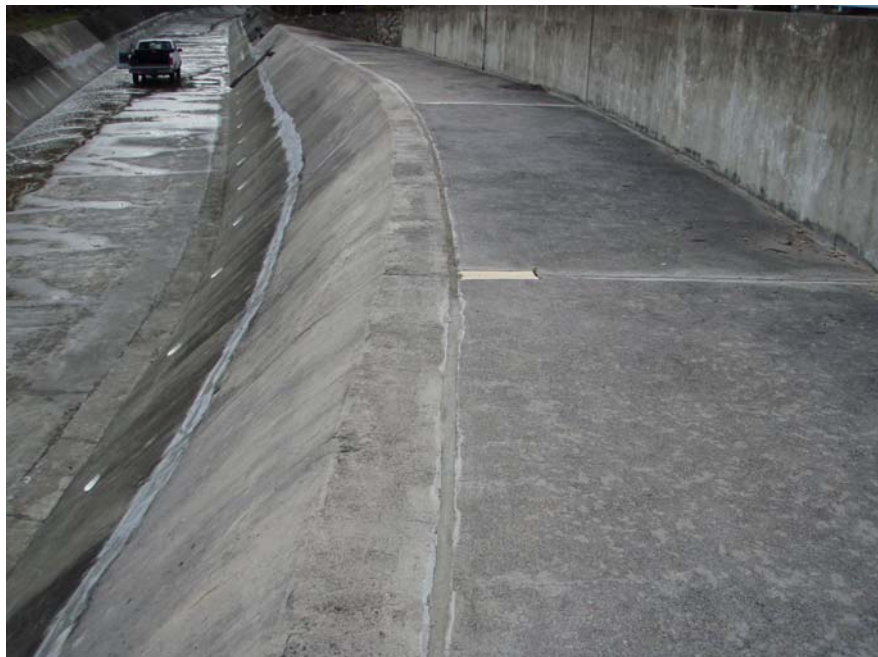
l. Sta. 27+50, RB, hinge separation sealed to prevent vegetation growth, monitor movement.

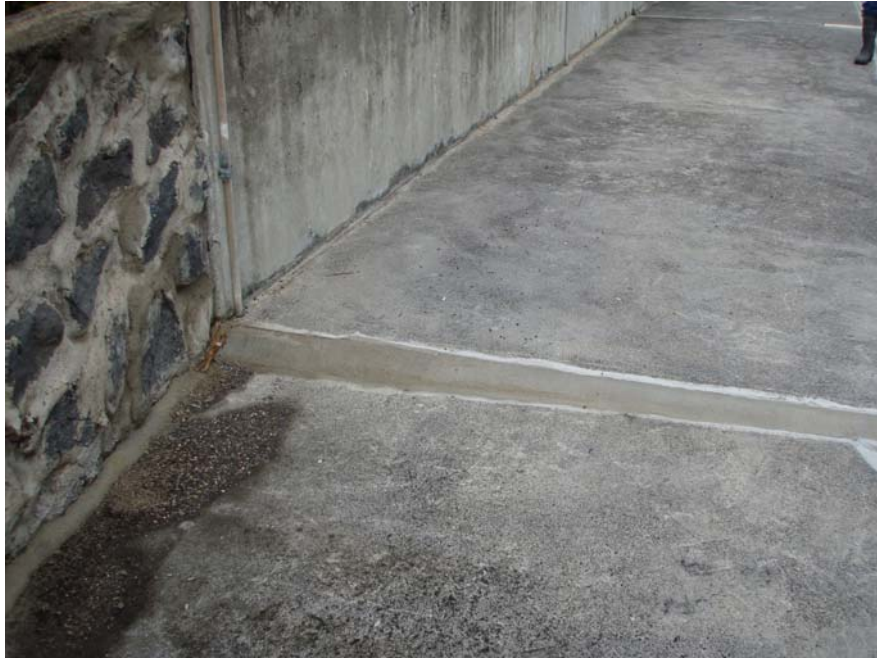
m. Sta. 27+50, RB, hinge separation sealed to prevent vegetation growth, monitor movement.

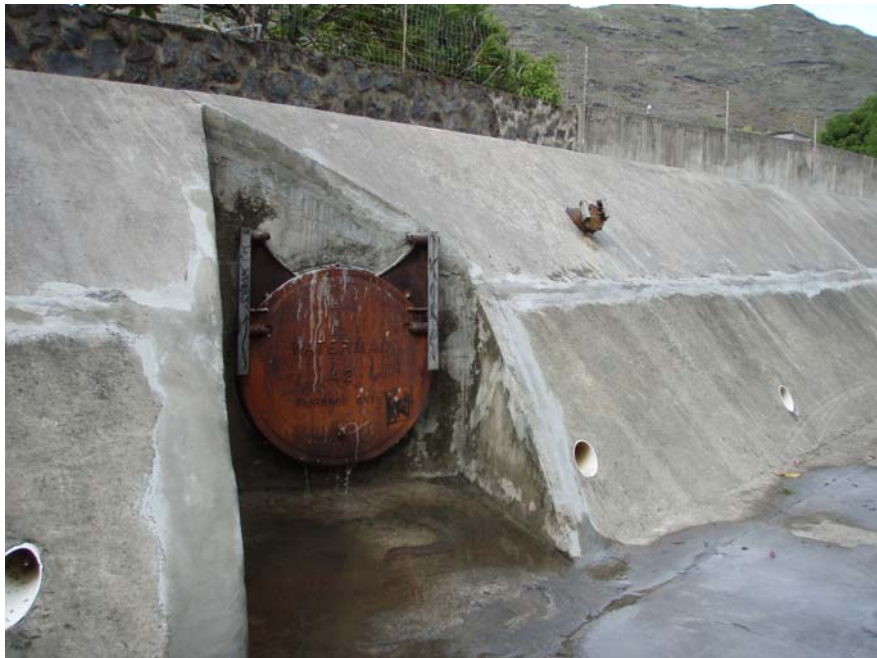
n. Sta. 27+50, RB, grease flapgate.

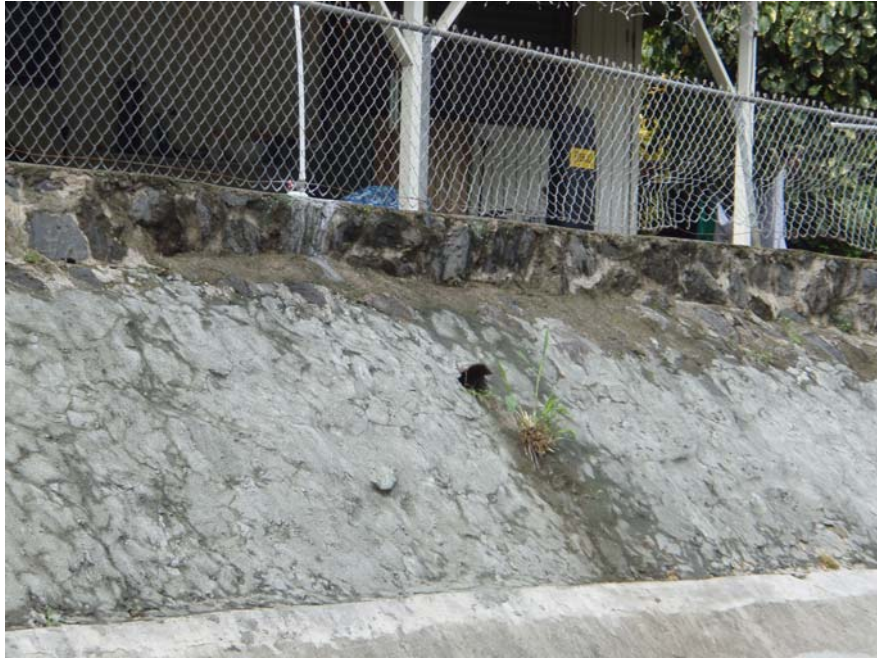
- o. Sta. 26+00, RB, 6" replace missing flapgate.

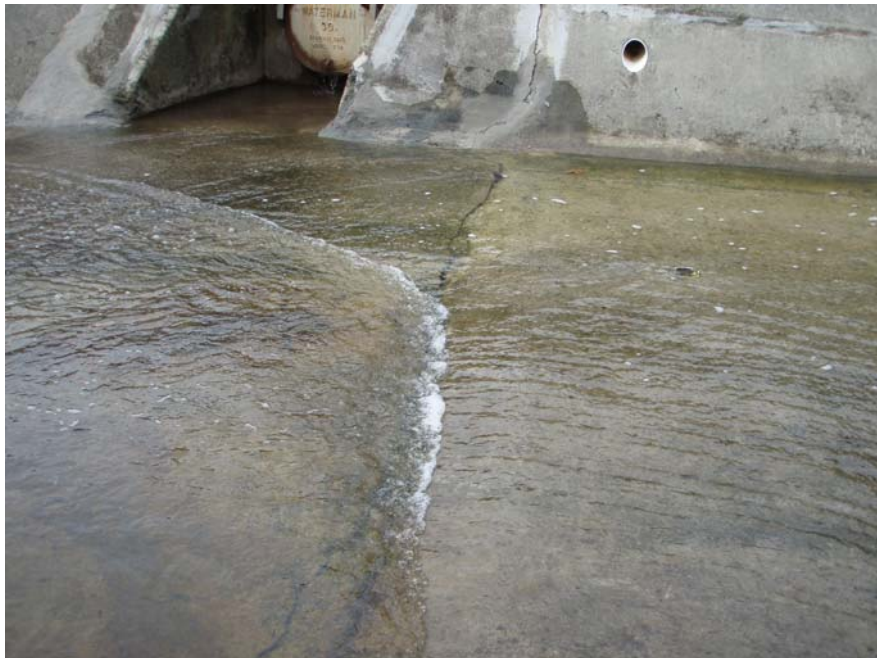
- p. Sta. 23+32, RB / invert patch cracks.

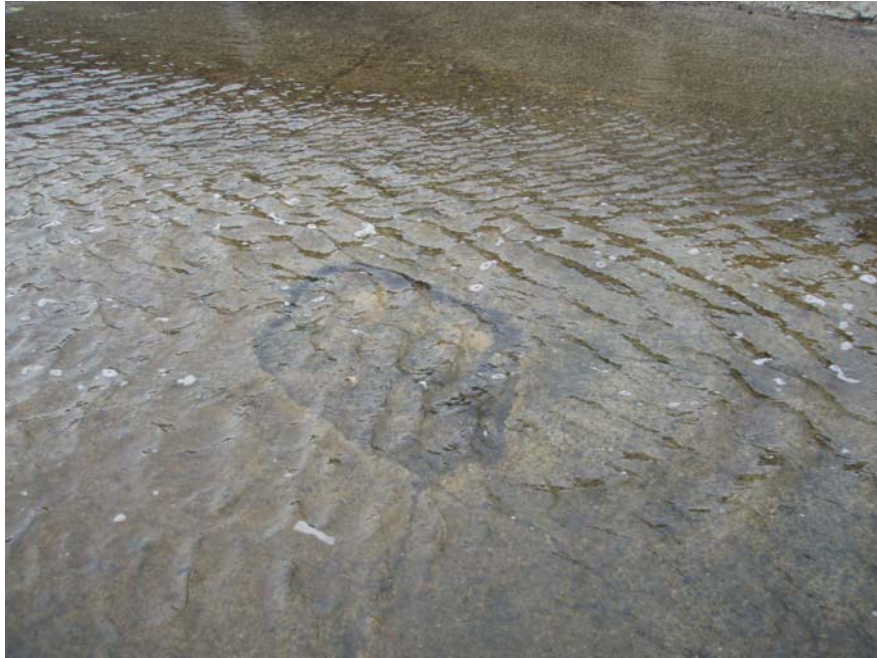
q. Sta. 22+90, invert, patch 3ea. holes.

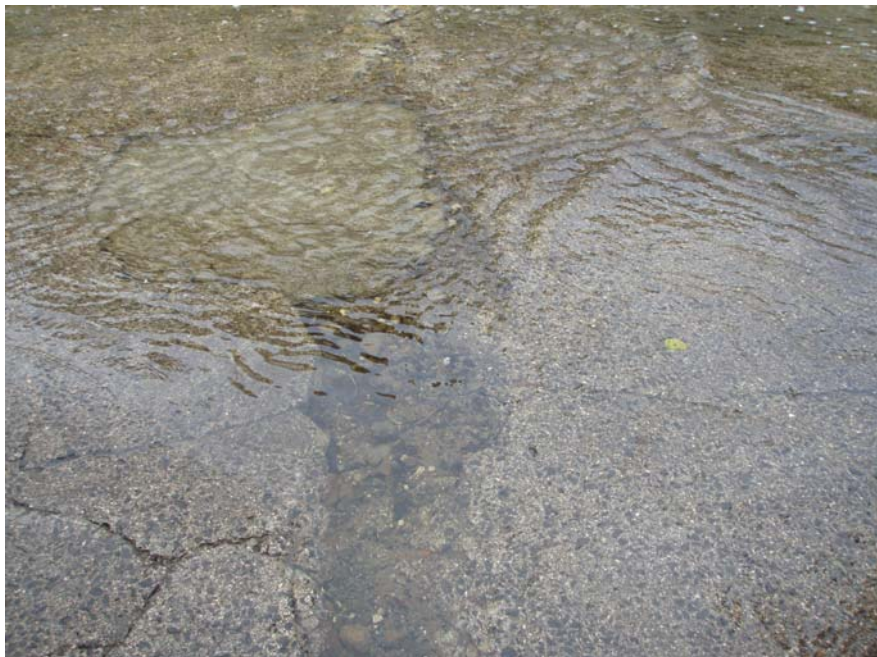
r. Sta. 21+00, Invert patch hole and replace missing station number and missing flapgate and repair invert.

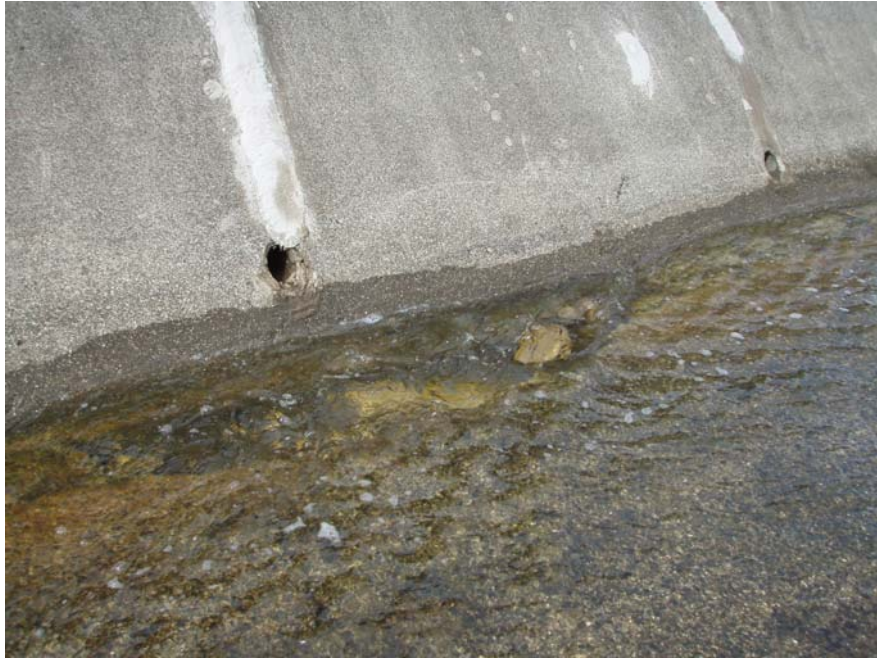
s. Sta. 21+00 to Sta. 19+00, Invert, repair cracks and holes.

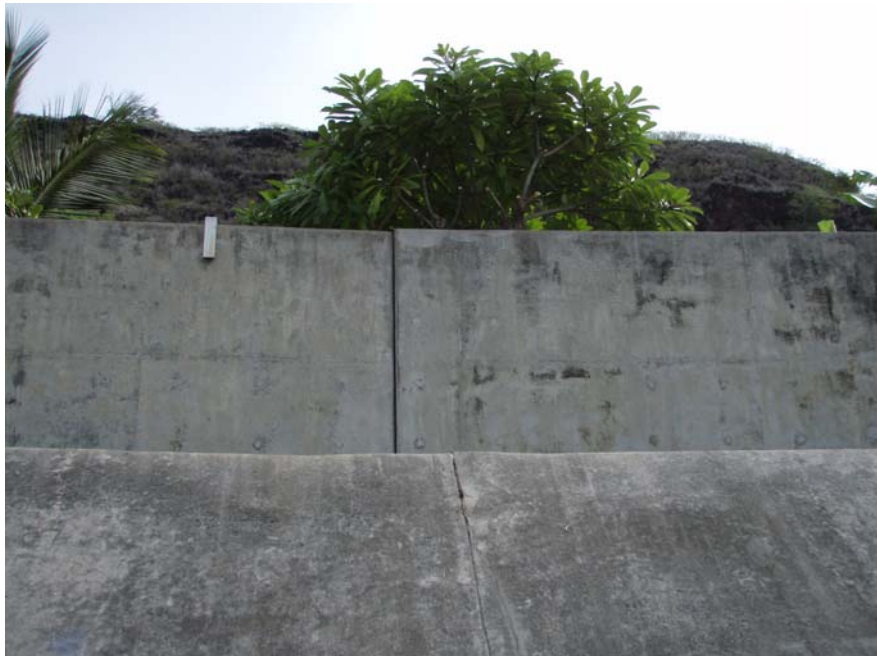
t. Sta. 20+75, LB, monitor construction joints for separation.

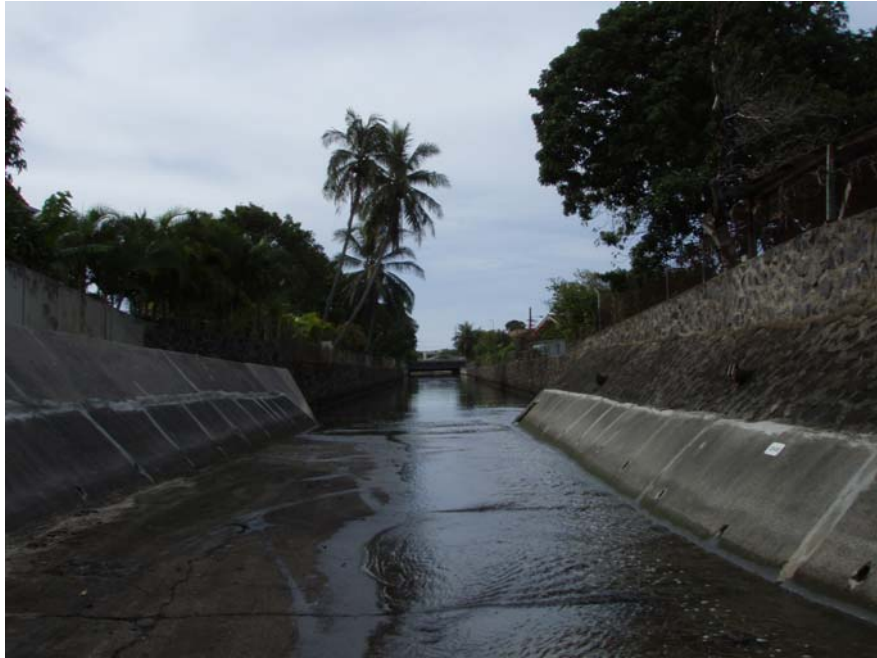
- u. Sta. 20+00, Invert continue to repair holes in invert.

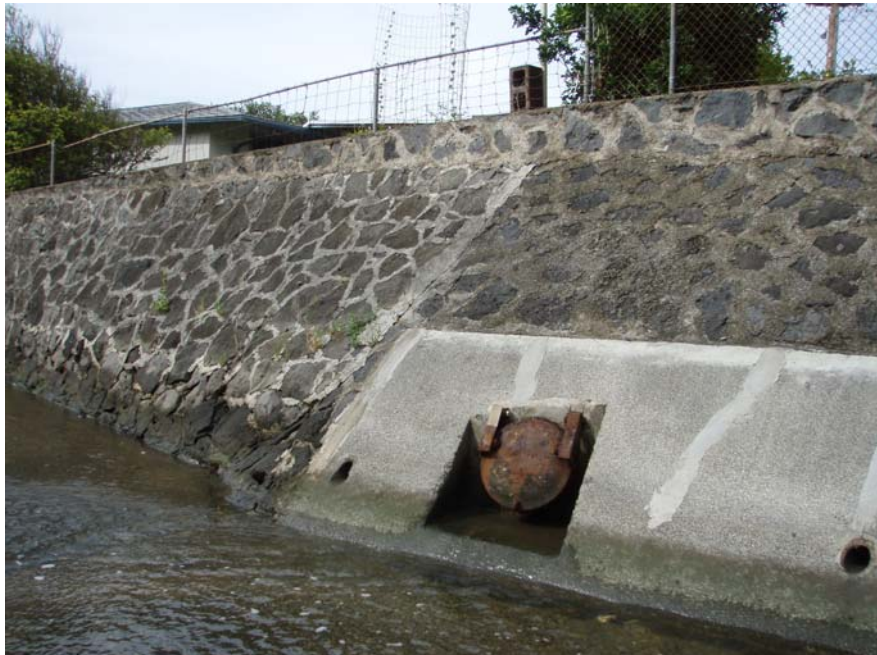
- v. Sta. 19+00, replace rusted / frozen 18" flapgate.

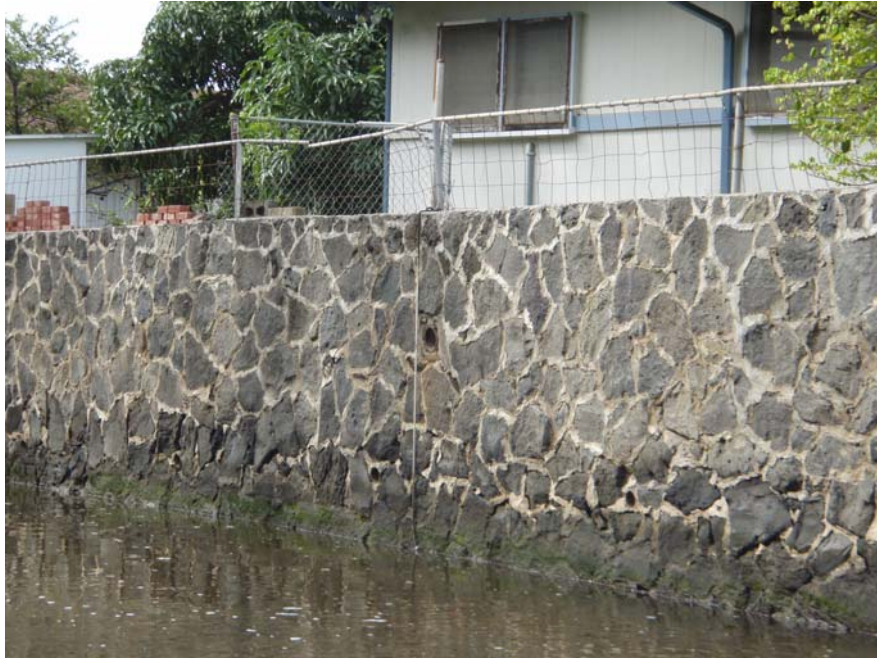
w. Sta. 18+40, RB, replace missing flapgate.

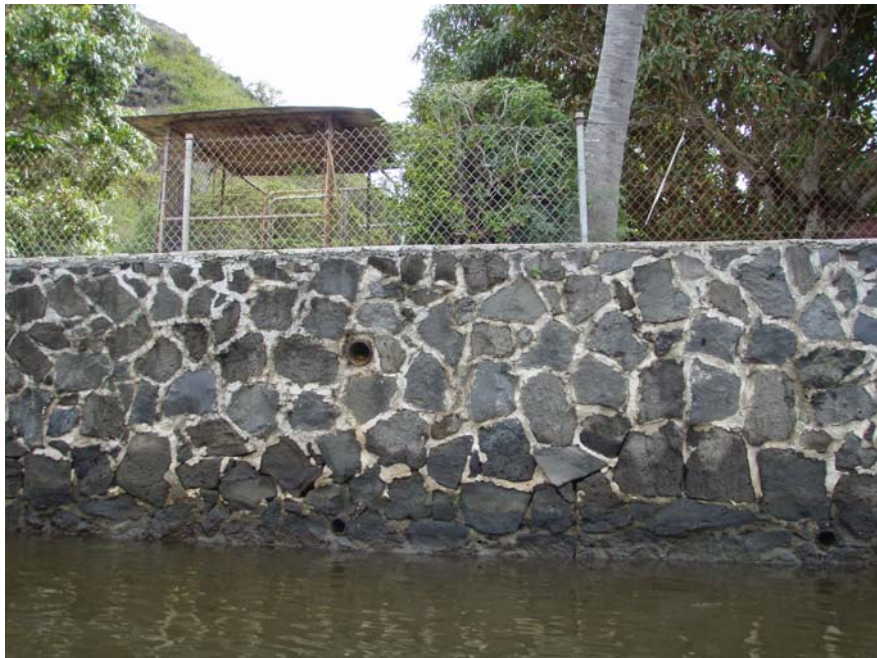
x. Sta. 16+00, LB, replace missing 6" flapgate.

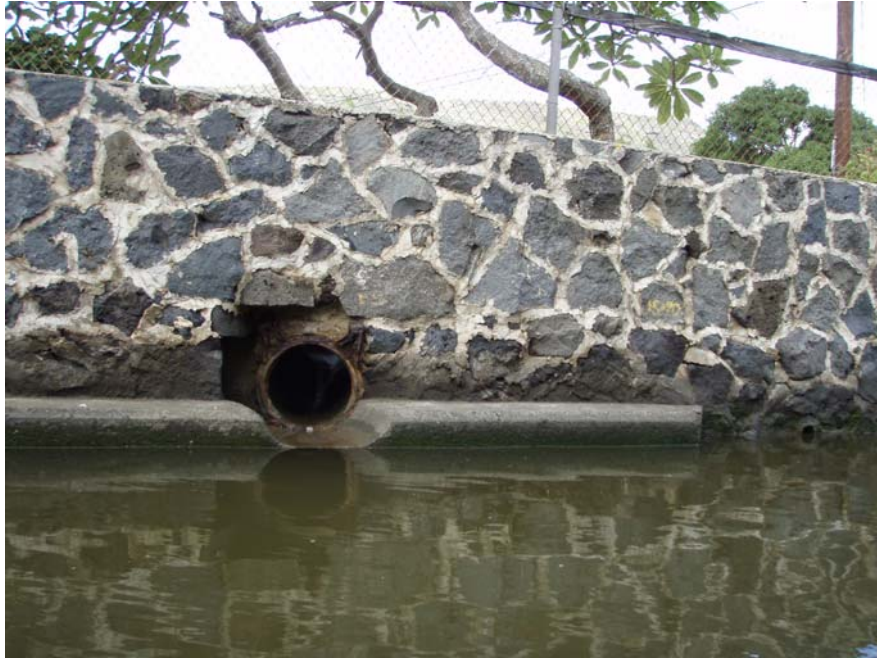
y. Sta. 15+00, RB, replace missing 18" flapgate.

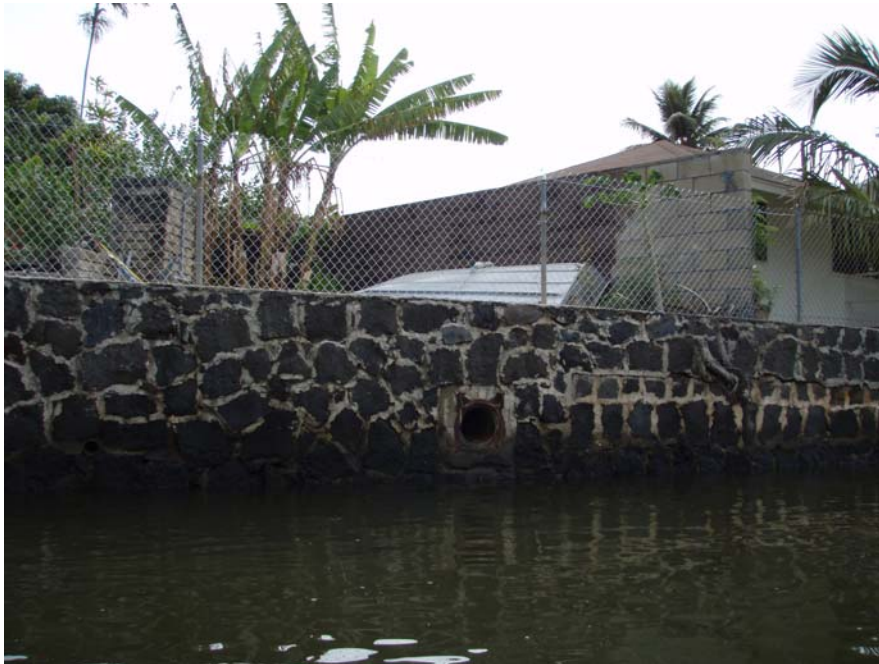
z. Sta. 13+00, LB, repair 2'x2' hole in CRM wall at the waterline, boat encroachment removed and fence repaired, install missing flapgate.

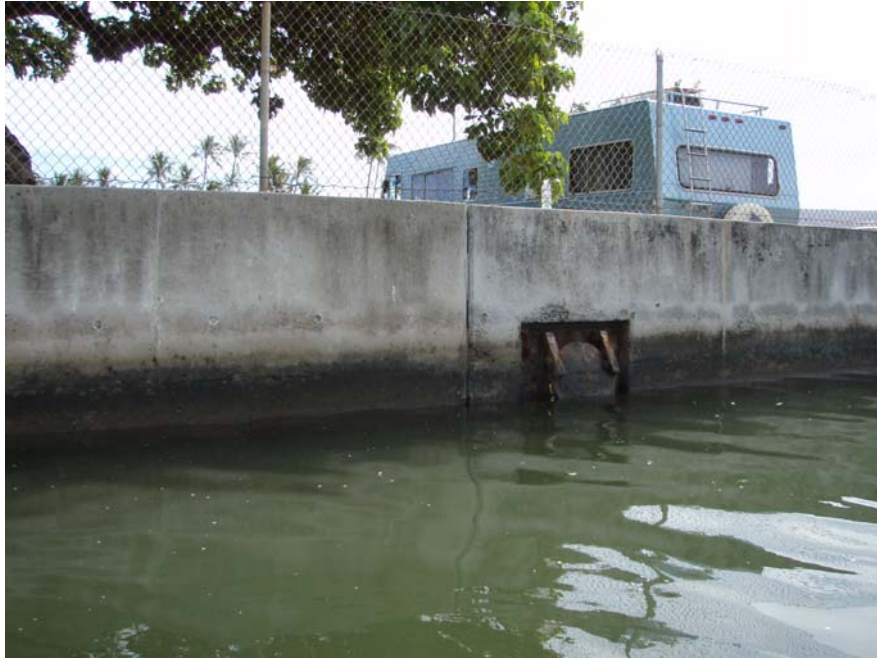
dd. Sta. 5+00, LB, 18" flapgate frozen open, replace.
